# Richmond Refinery LPS Bulletin – Reliability

## TK-400 Shutdown Due to Gasket Failure (Steam Leak)

Richmond Refinery – North  
ISOMAX – TKC Recycle  
Gas Compressor

Investigation 19897

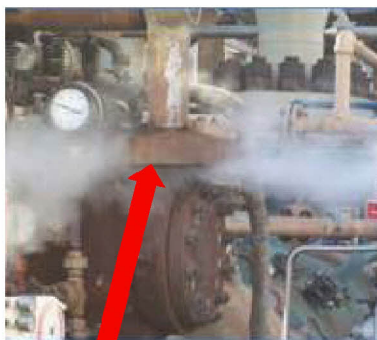
Photo of steam leak at the TK-400 inlet steam valve assembly gasket/cover

On February 19<sup>th</sup>, 2012 a steam leak was discovered at the inlet steam valve assembly gasket/cover of K-400, which caused 150# steam to be released into the surrounding area. The leak was severe enough the machine was shut down. This type of steam leak had the potential to be both a high level reliability incident as well as a safety incident. Due to the machine being shutdown proactively both potential consequences were mitigated/minimized.

- 1) Gasket found in the split line was incorrect for the service.
- 2) During the previous overhaul, the asbestos gasket (original) had been replaced with a standard paper sheet type gasket.
- 3) No MOC was completed for this gasket type change.
- 4) The Gasket was installed by the Original Equipment Manufacturer employees and the materials were provided by Chevron.

- 1) Gasket selection was not reviewed by the proper experts due to a lack of knowledge of the impact of using these types of paper gaskets in hot steam service.
- 2) The selected gasket material was not adequate for the elevated temperature service in which it was installed.
- 3) There was no information readily available containing the proper gasket type or torque specs required.

- 1) Add specific engineered gasket information and torquing procedures to Maximo work orders for future TK-400 work.
- 2) Recognize the risk of changing gasket material on high temperature equipment.
- 3) Emphasize the requirement of the MOC process at any time that materials have changed.
